INDOOR AIR QUALITY REASSESSMENT

**Central Elementary School
107 Central Street
East Bridgewater, Massachusetts**

Prepared by:
Massachusetts Department of Public Health
Bureau of Environmental Health Assessment
May, 2000

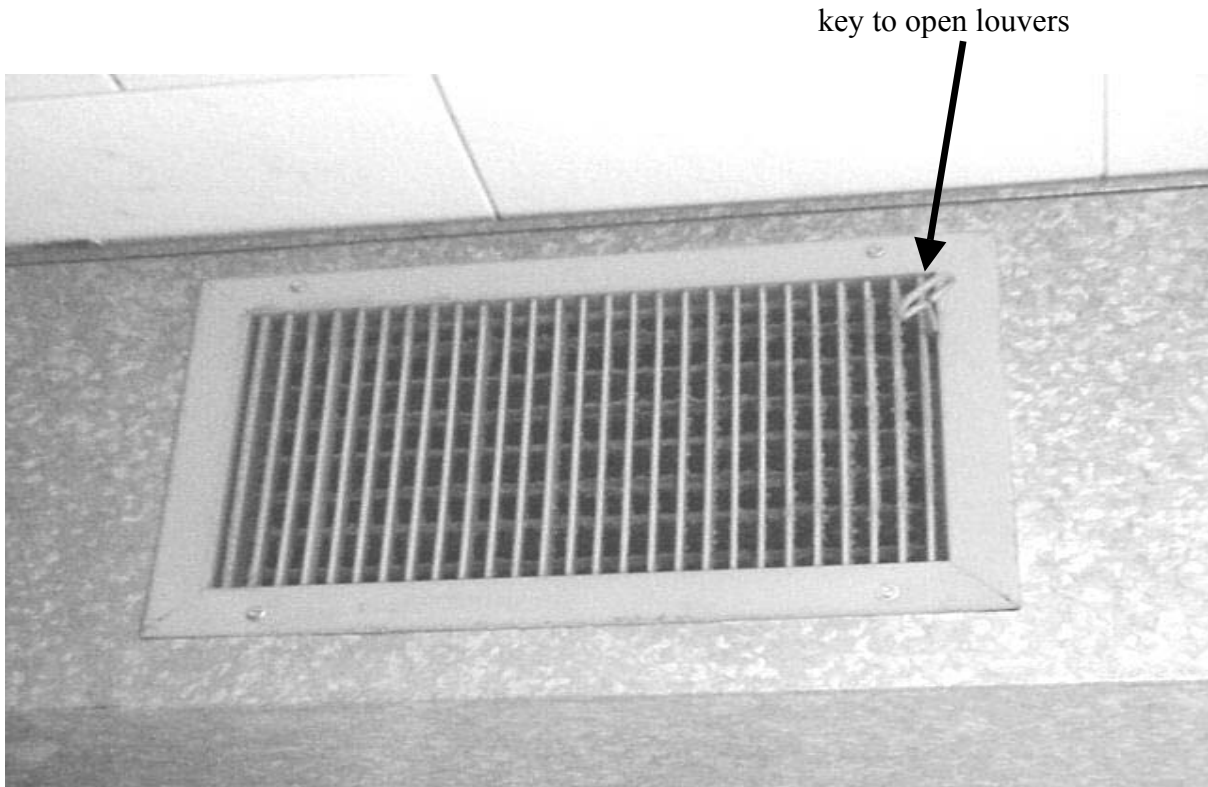
Picture 1

Vents in the special services area were found partially closed (see Picture 1).

**Vent in Special Services Area Noted with Louvers Closed
Note Key to open Louvers**

These vents should be checked daily to ensure they are open to facilitate airflow.

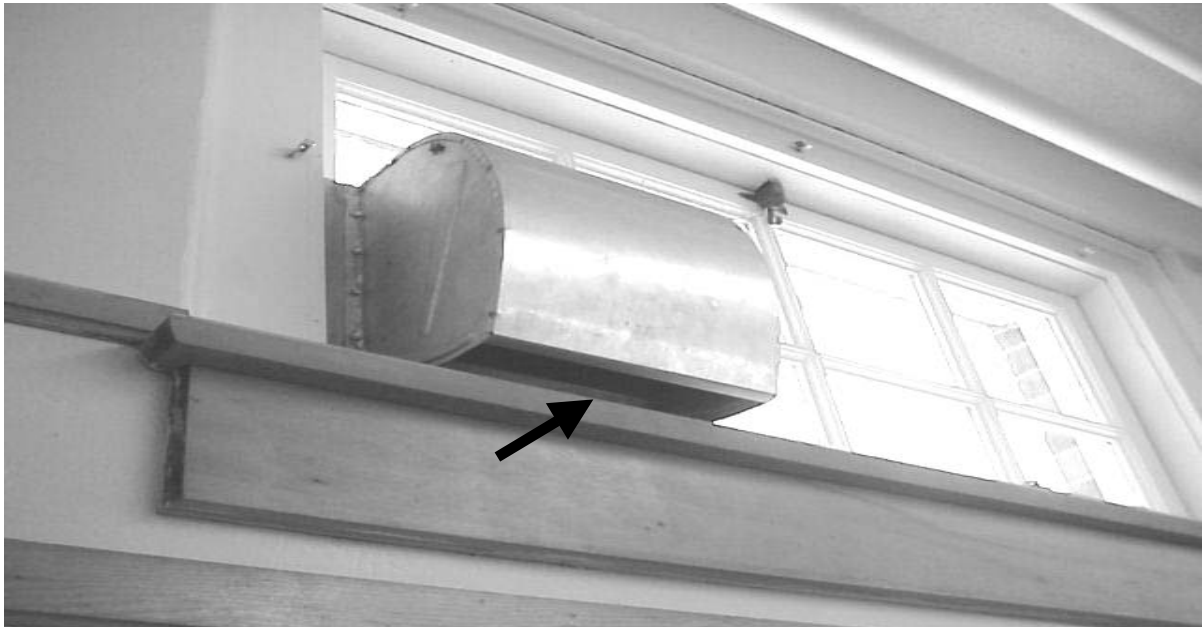
Picture 2

Exhaust vents in classrooms throughout the building were functioning. Exhaust ventilation was installed in room 11 (see Picture 2). Since the vent opening is partially blocked, BEHA staff recommended replacing the vent duct with an alternate configuration that would render the vent opening unobstructed.

**Window-Mounted Exhaust Vent Located in Classroom 11
Note Windowsill Obstructing Vent Opening**

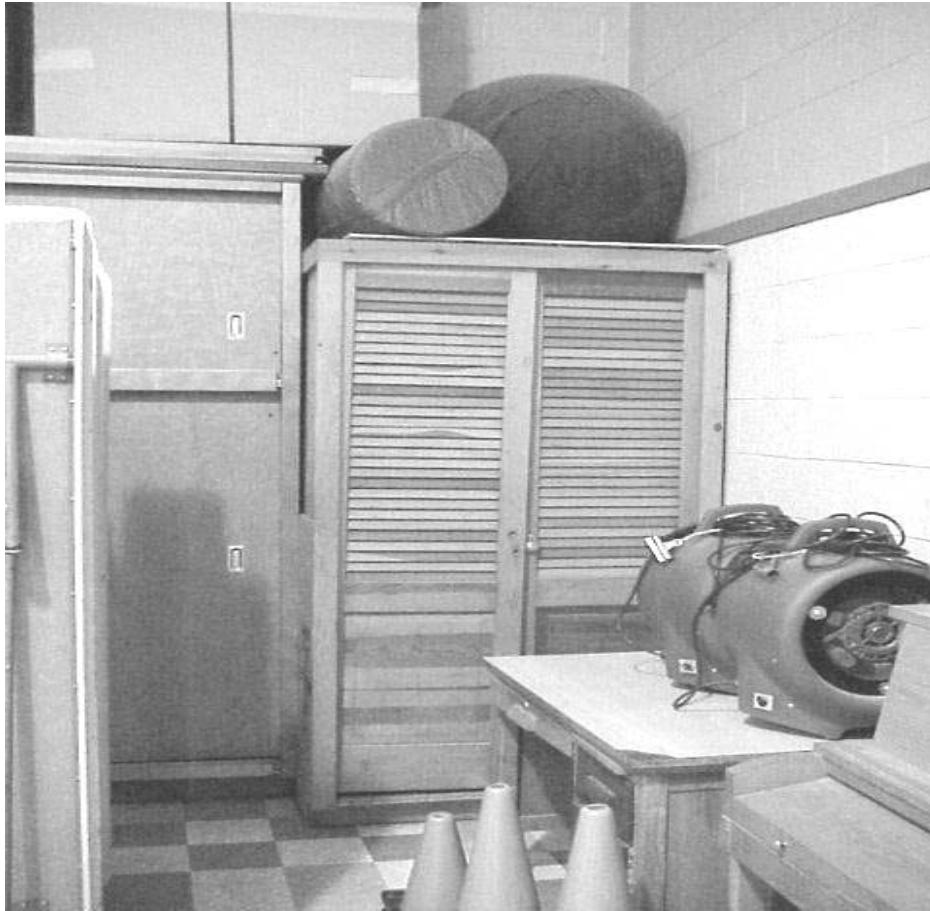
Picture 3

It was apparent to BEHA staff that occupants have been instructed to remove blockages to univents and exhaust vents, however in a few cases exhaust vents continue to be obstructed in classrooms (see Pictures). More work is needed in this area. Exhaust ventilation for the cafeteria is located behind a large cabinet

Large Cabinet in Cafeteria Obstructing Wall-Mounted Exhaust Vent

(see Picture 3). BEHA staff recommended relocating the cabinet to allow airflow into the exhaust vent.

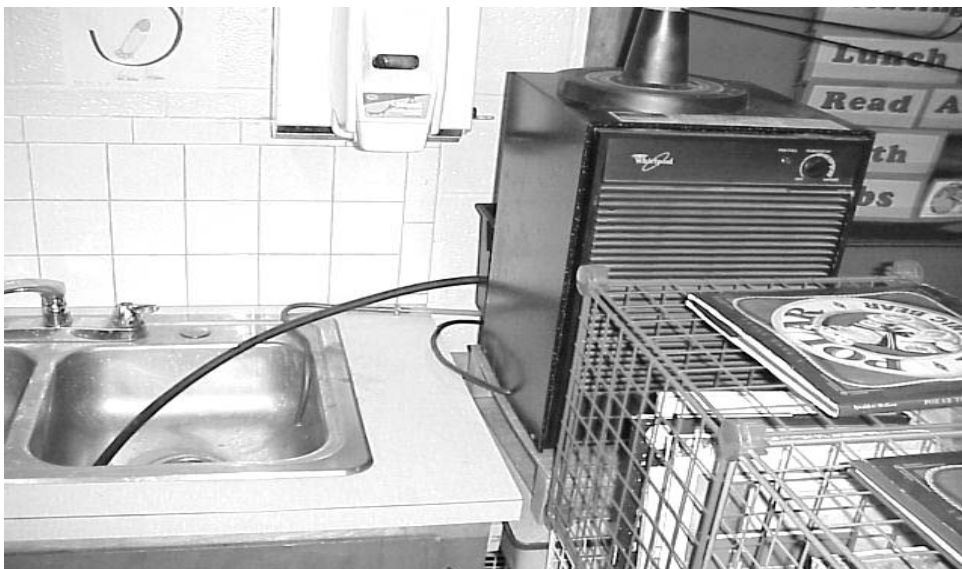
Picture 4

Dehumidifiers were cleaned and will reportedly be cleaned regularly by school maintenance personnel. In addition, the dehumidifier in classroom 11 has been modified to empty directly into the sink via a hose (see Picture 4).

Dehumidifier Draining into Sink in Room 11

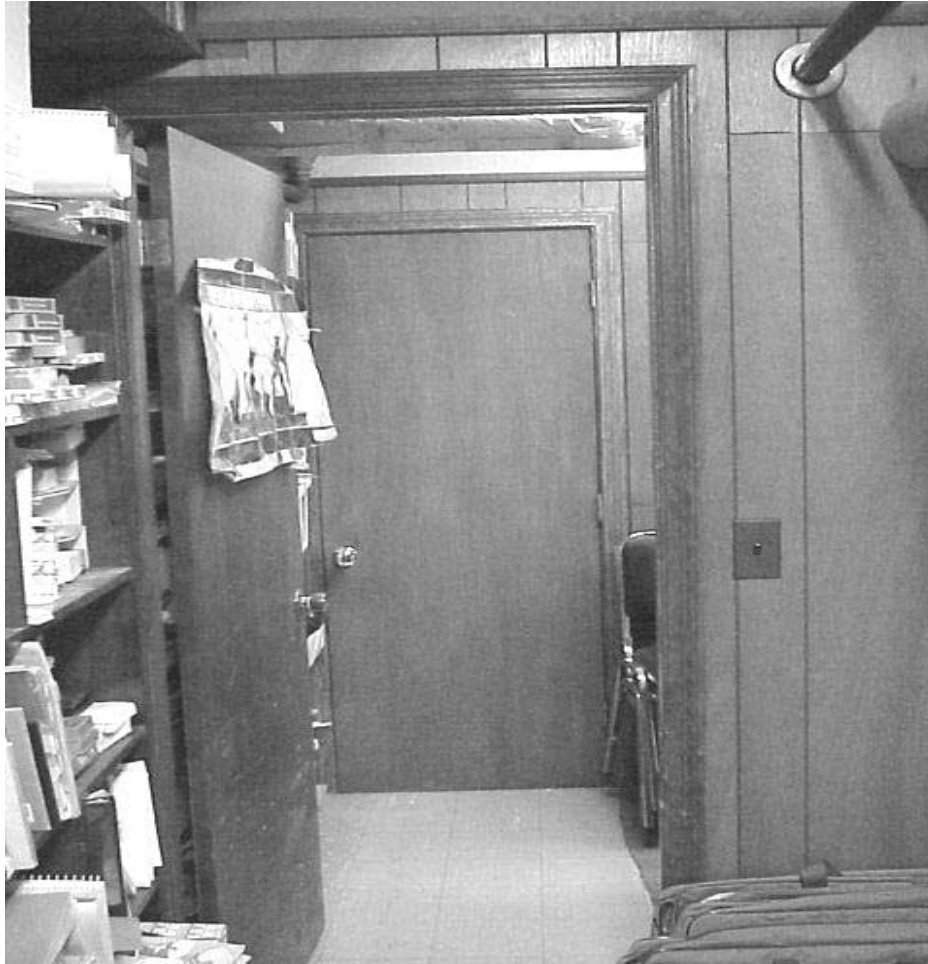
Picture 5

A door was installed in this area to provide a barrier between the mechanical room and the occupied space (see Picture 5). BEHA staff recommended that weather-stripping be installed beneath and around the door to prevent the infiltration of odors into the adjacent space.

Door Installed to Mechanical Room in the Special Services Area

8. Seal door to mechanical room in the special services area to prevent penetration of odors and/or drafts.
9. Store chemicals and cleaning products properly and out of the reach of students. Ensure all containers are properly labeled for identification in the event of an emergency.

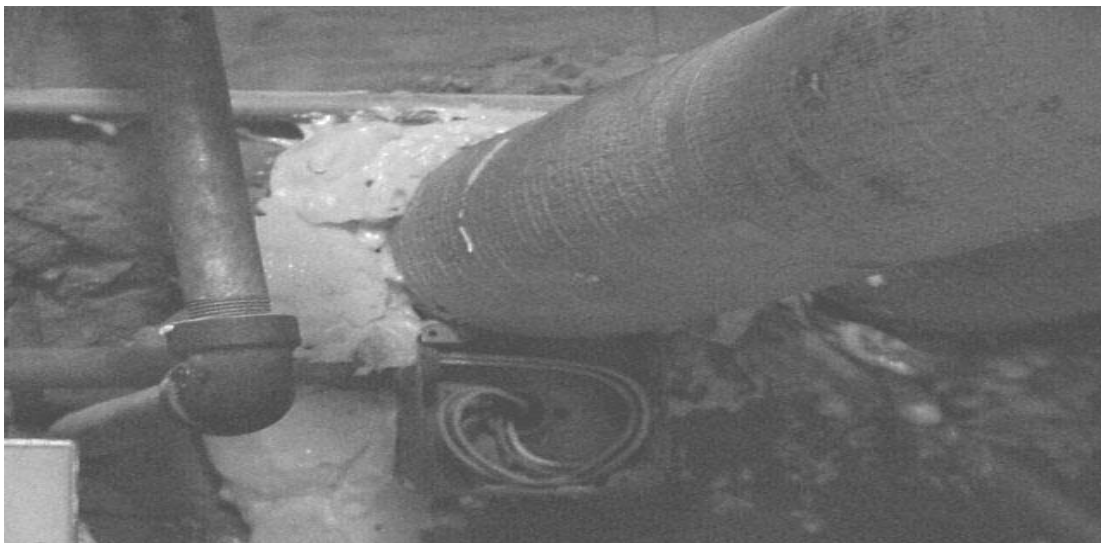
Picture 6

Utility holes were sealed on both sides of the wall between the boiler room and the special services area with foam insulation (see Picture 6). Loose fiberglass insulation was also secured with tape.

**Utility Holes in Mechanical Room (Special Services Area)
Note Holes are Sealed with a Foam Material**

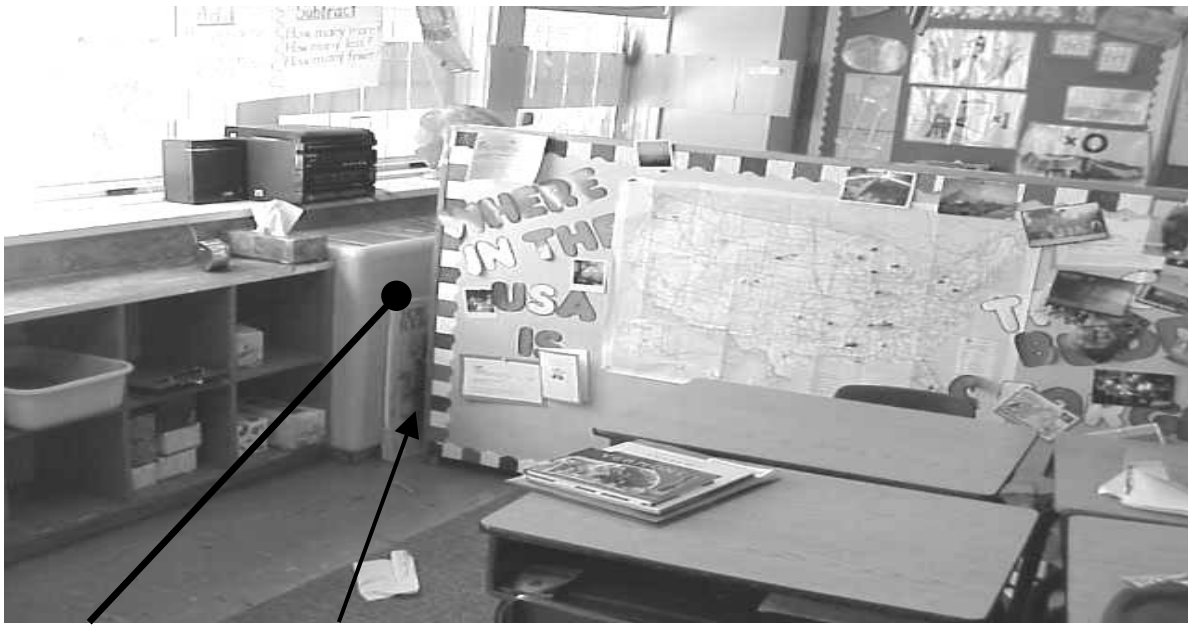
Picture 7

Classroom Univent Note Classroom Divider Obstructing Airflow to/from Univent

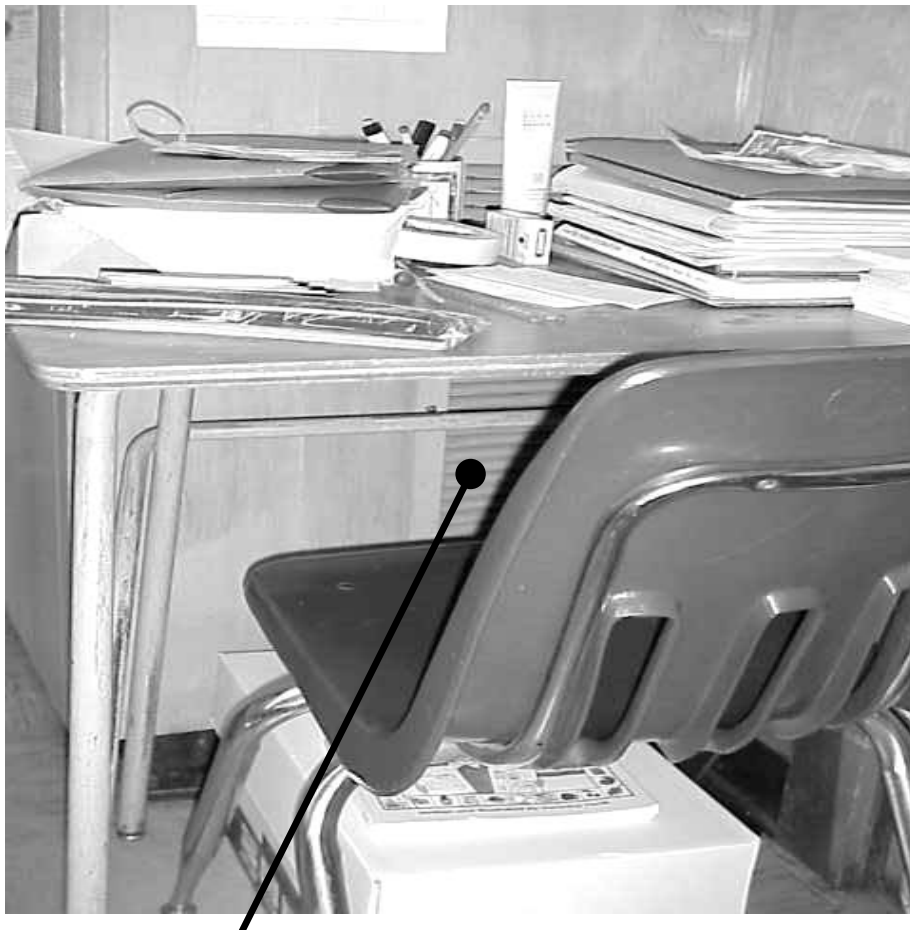
Picture 8

Classroom Exhaust Vent Obstructed by Table and Chair

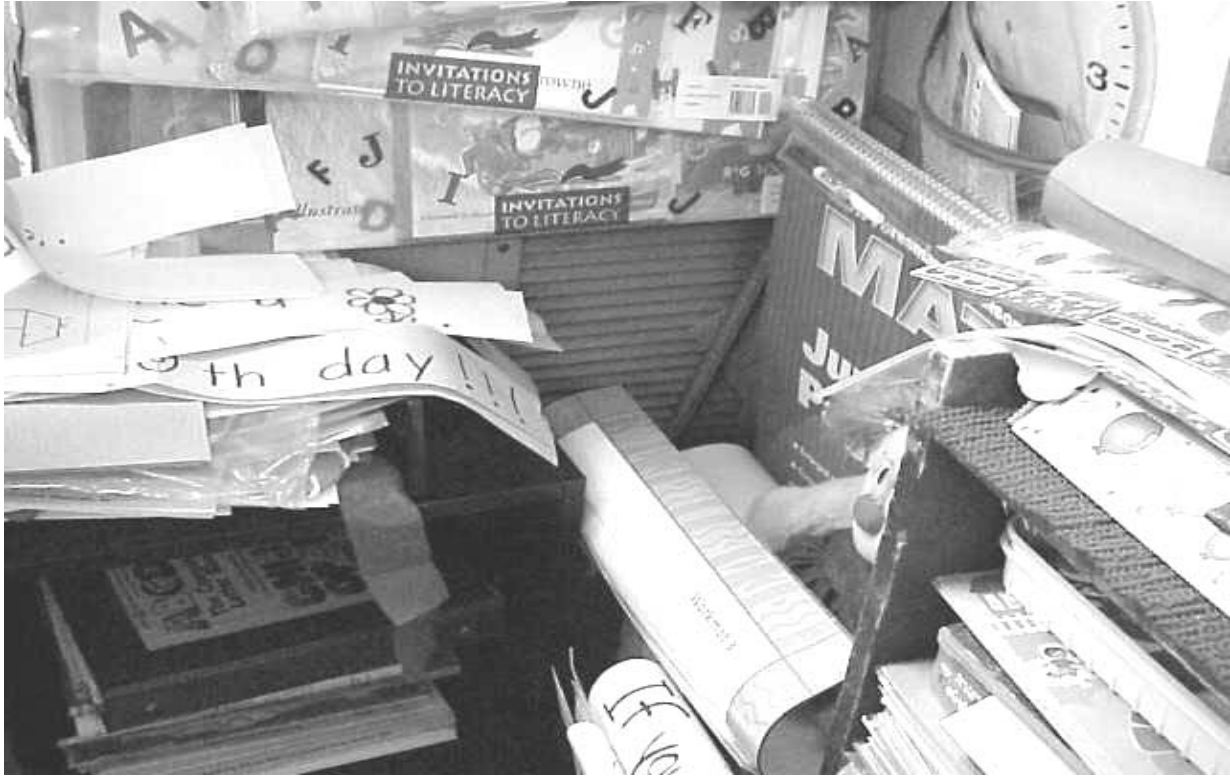
Picture 9

Classroom Exhaust Vent Obstructed by Various Items

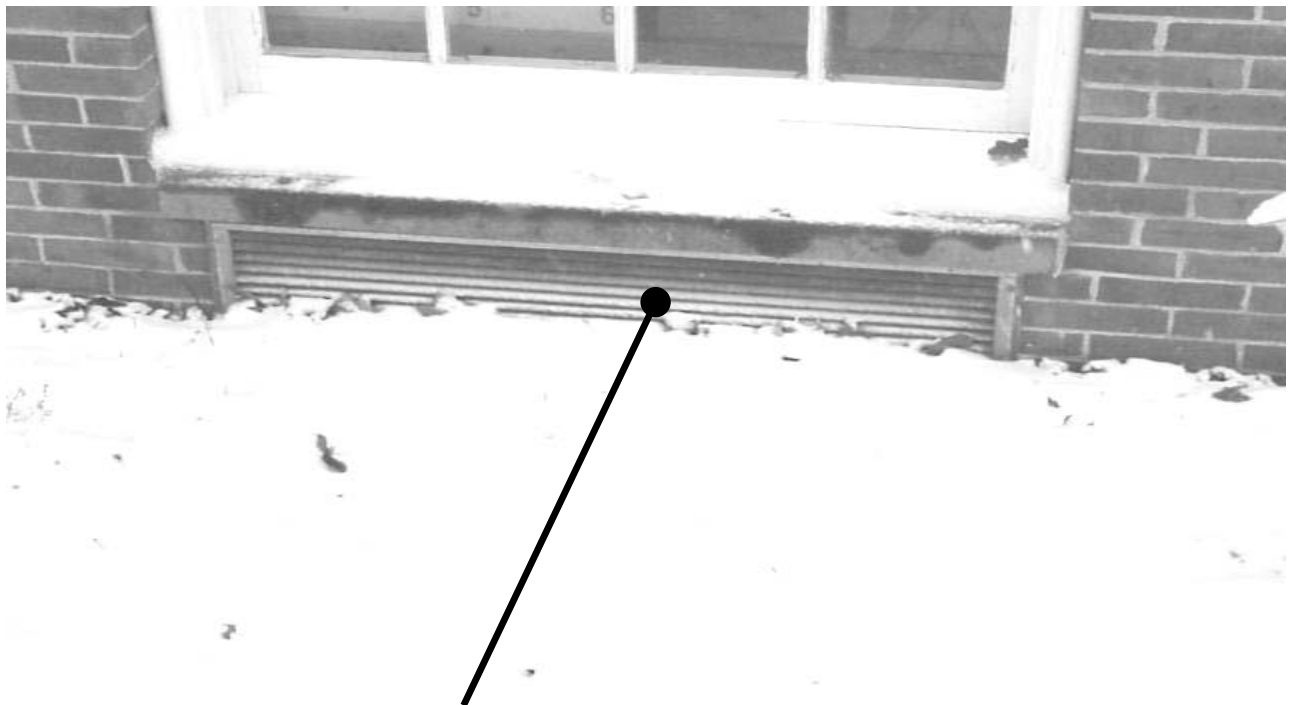
Picture 10

The January 13th visit occurred on a day of heavy snowfall. Along the perimeter of the building, univent fresh air intakes were noted partially covered with snow (see Picture 10). Care should be taken to ensure that fresh air intakes remain clear of obstructions (e.g., snow, shrubbery, etc.) to avoid the entrainment of dirt, moisture and or pollen.

Univent Fresh Air Intake Partially Covered with Snow
